Technical Report M13

**BANK EROSION STUDY OF THE KASKASKIA RIVER,  
CARLYLE LAKE  
TO NEW ATHENS, ILLINOIS**

Prepared For  
U.S. Army Corps of Engineers  
St. Louis District

February 2000

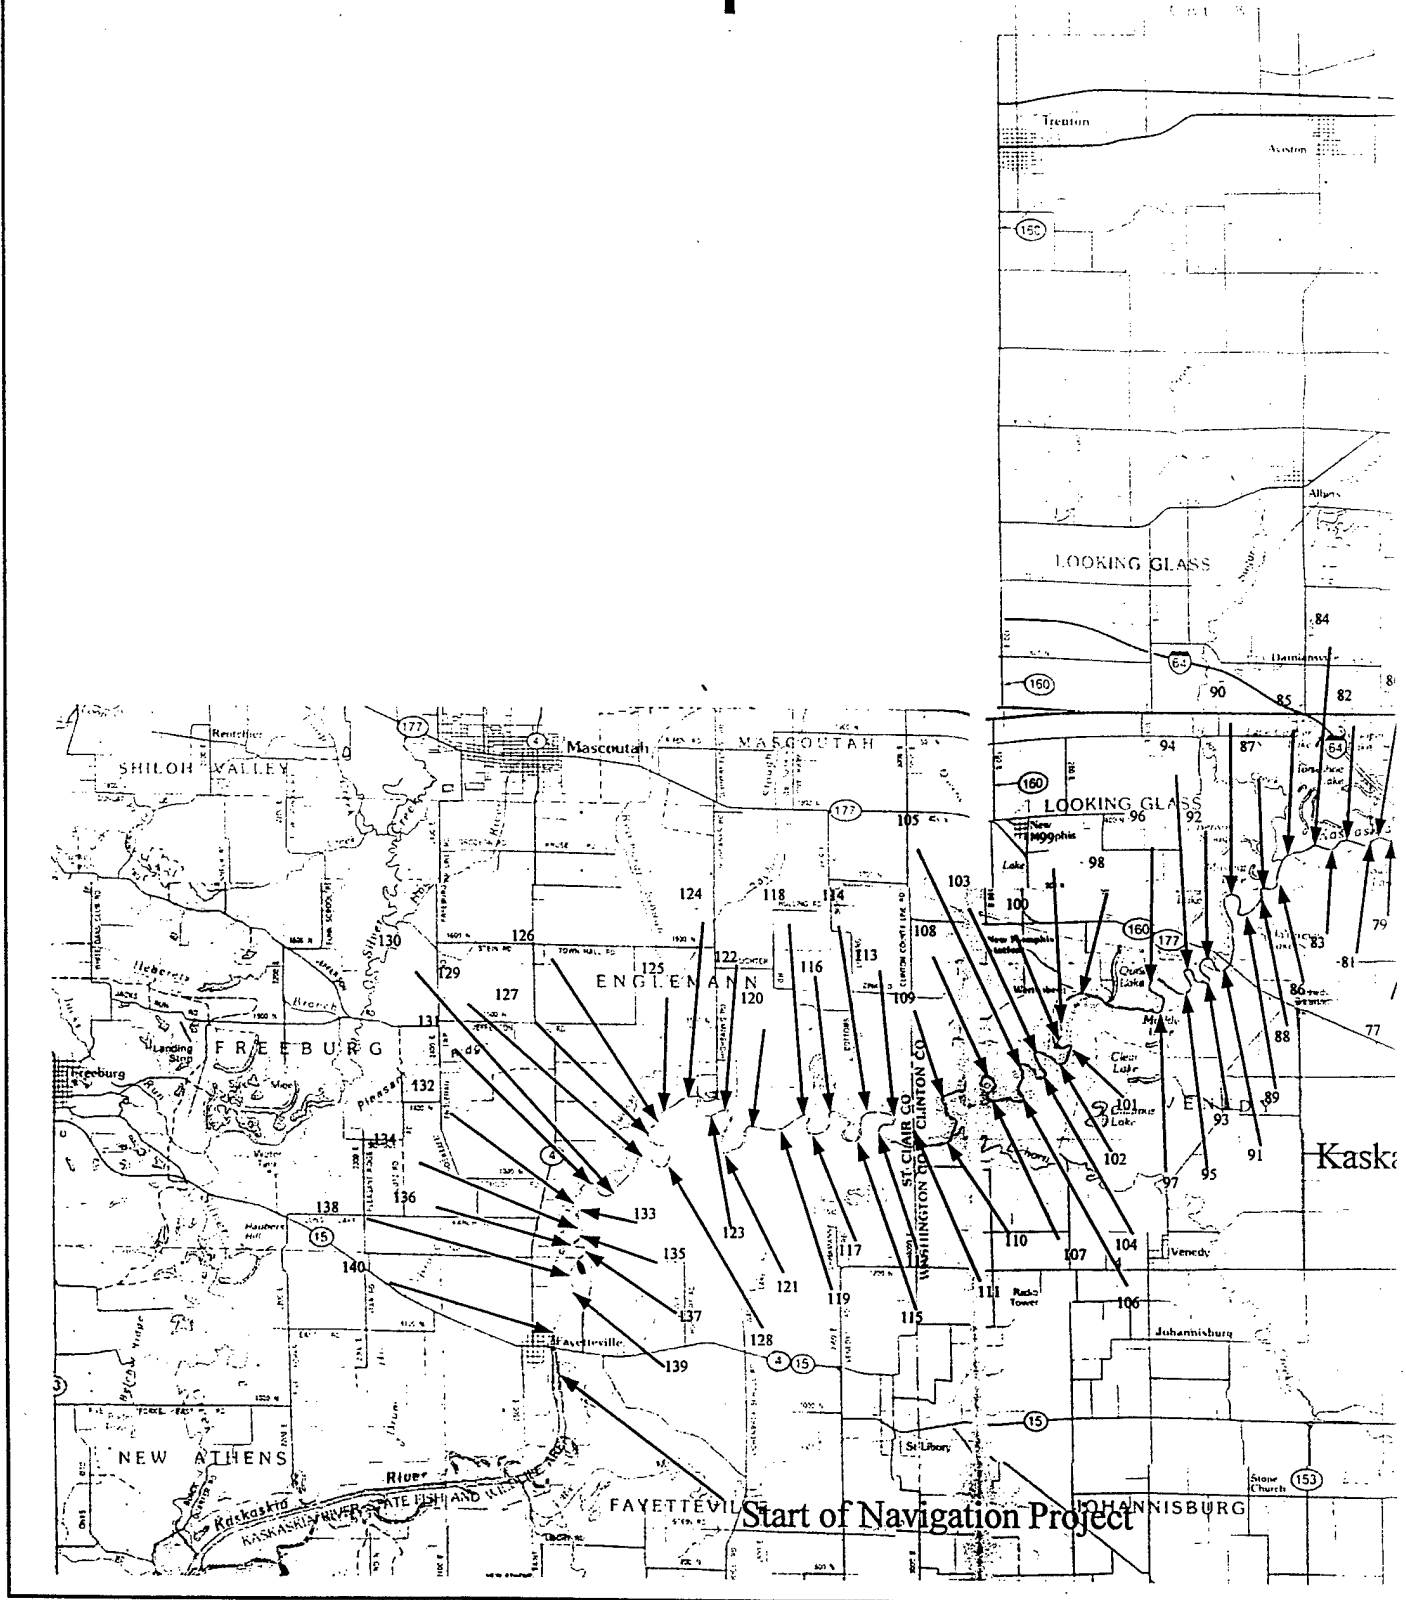
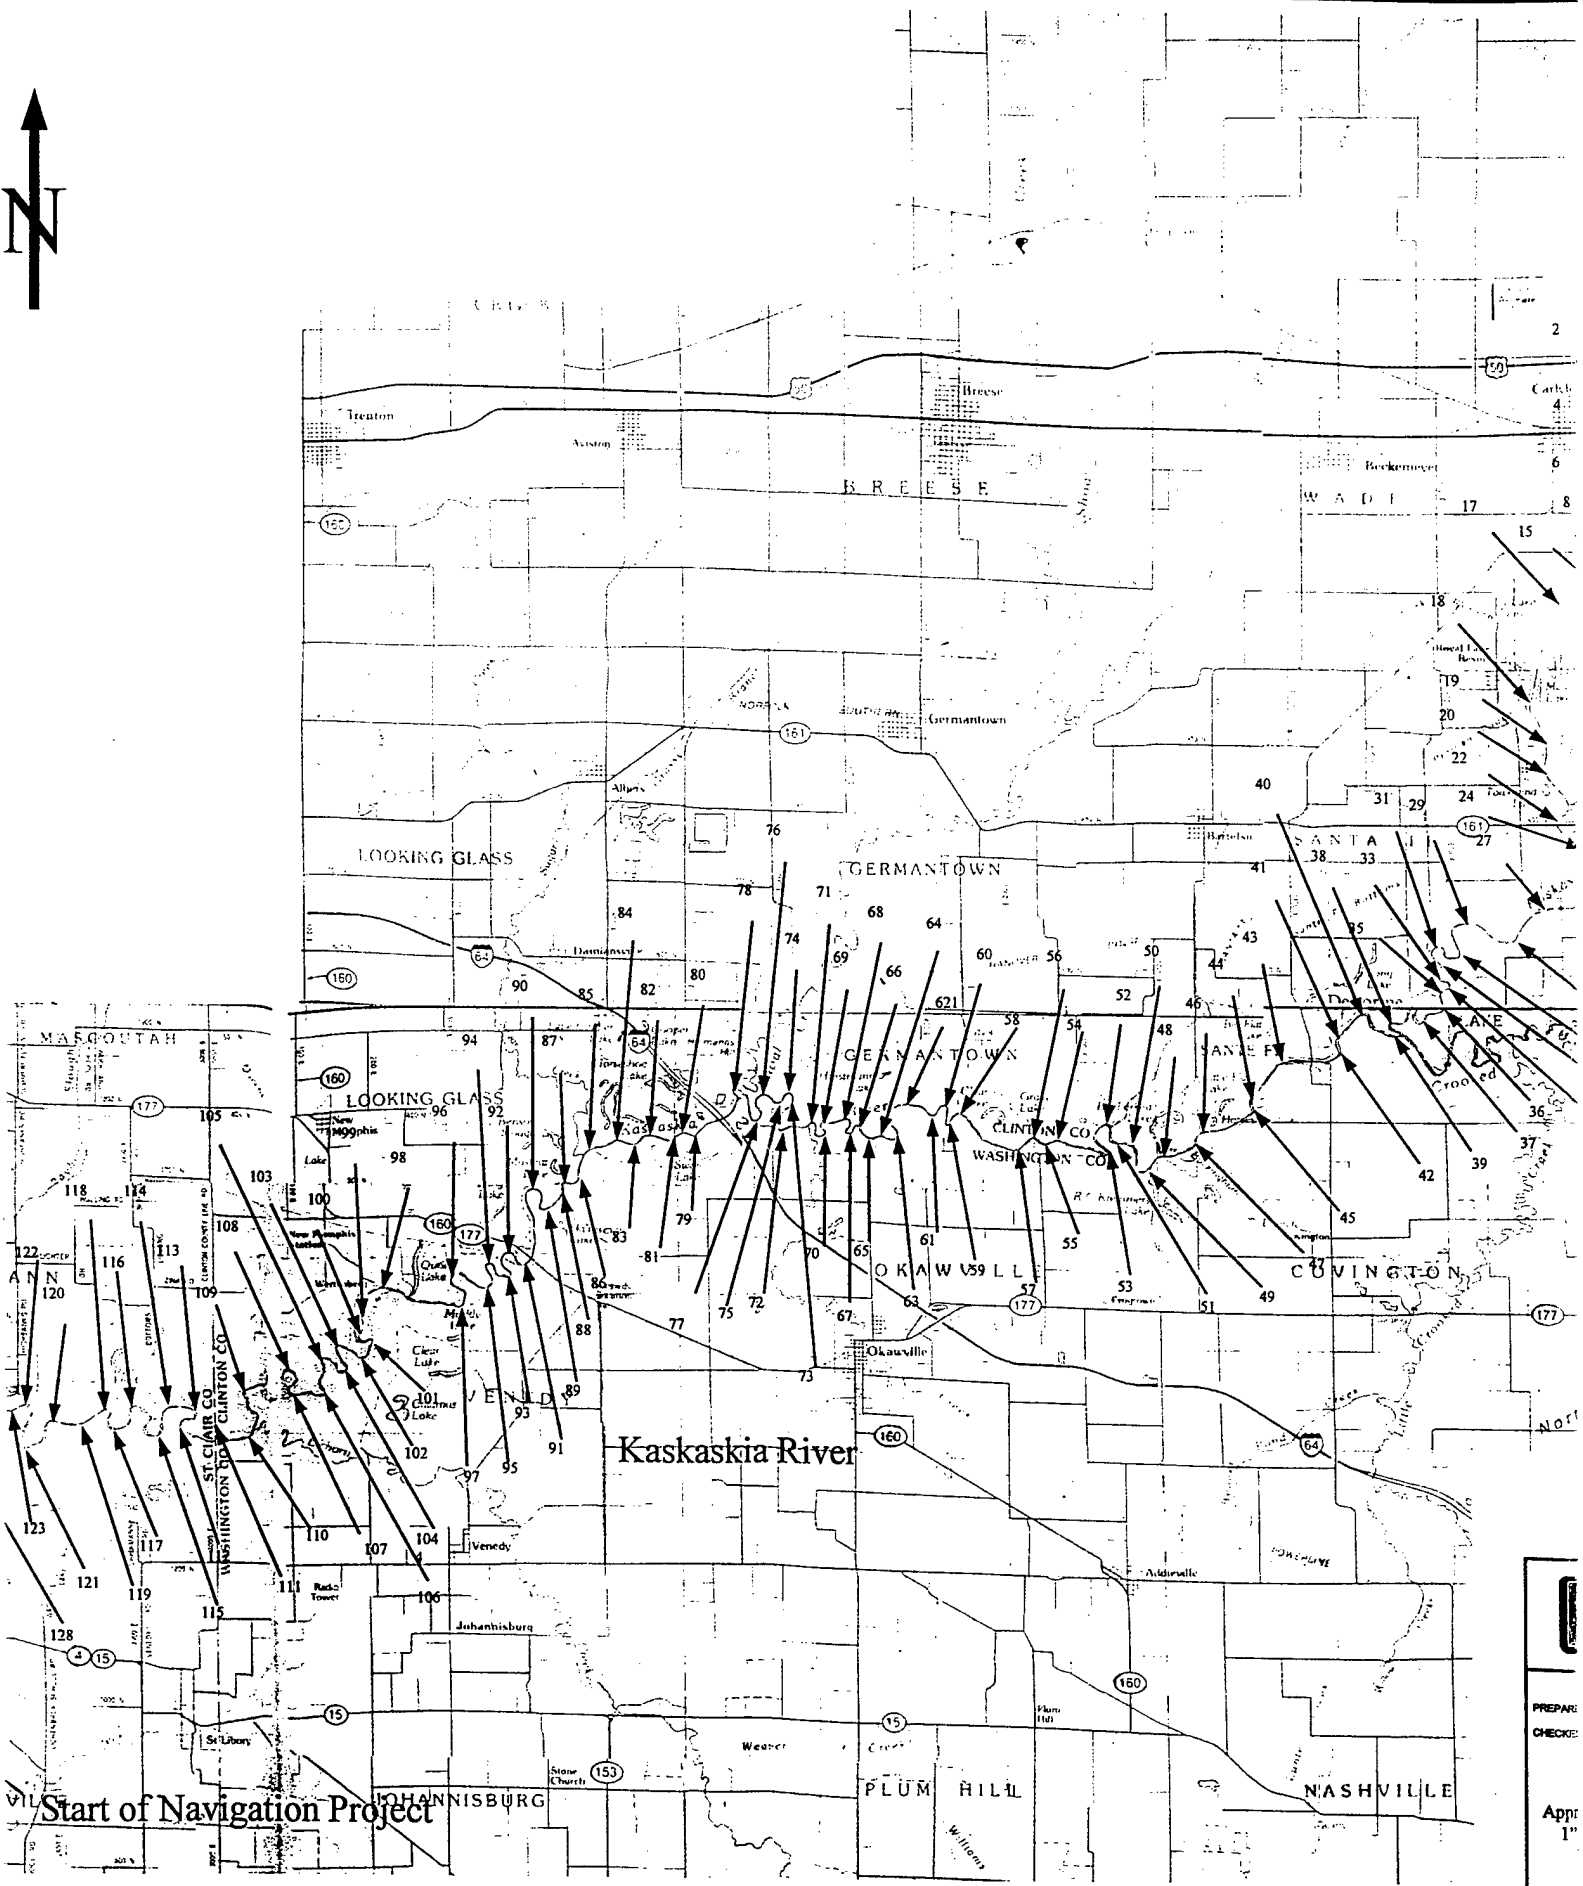
DESIGN FILE: PROJECT\KASKY\DCM\KASK2936.DGN PLOT SCALE: 2000	PLOT DATE: JAN 18, 2000 PLATE NO. 3

No dredging has occurred in the navigation channel since 1985. Hydrographic surveys of the channel conducted in 1999 indicated that approximately 1.77 million cubic yards of sediment had again accumulated in the 6-mile stretch of the navigation project, between Fayetteville and New Athens (Plate 3).

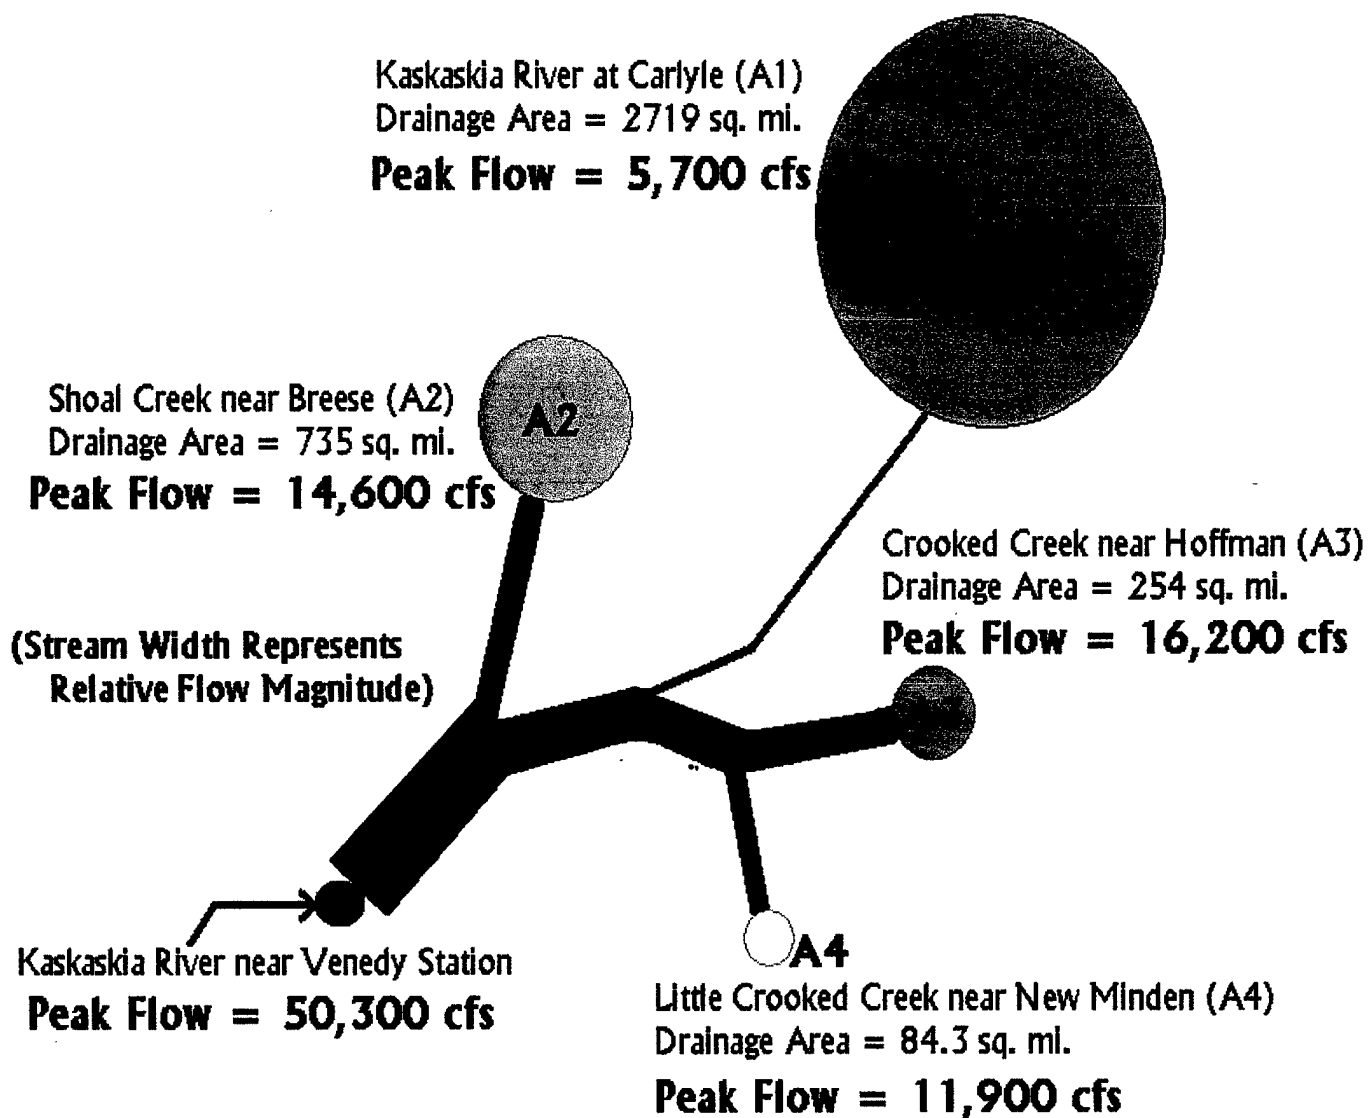
# 1995 Flow Comparison Kaskaskia River Basin

The positive effects of the reservoirs can further be identified by examining downstream flow contributions from tributaries below Carlyle Lake during high water events. Plate 10 is a schematic illustrating the relative flow contributions at Vennedy Station (at Highway 160 Bridge) from Shoal Creek, Crooked Creek, Little Crooked Creek, and reservoir releases from Carlyle Lake. The diagram demonstrates that high flows experienced at Vennedy Station are not a result of reservoir releases but rather natural flow contributions from the tributaries.

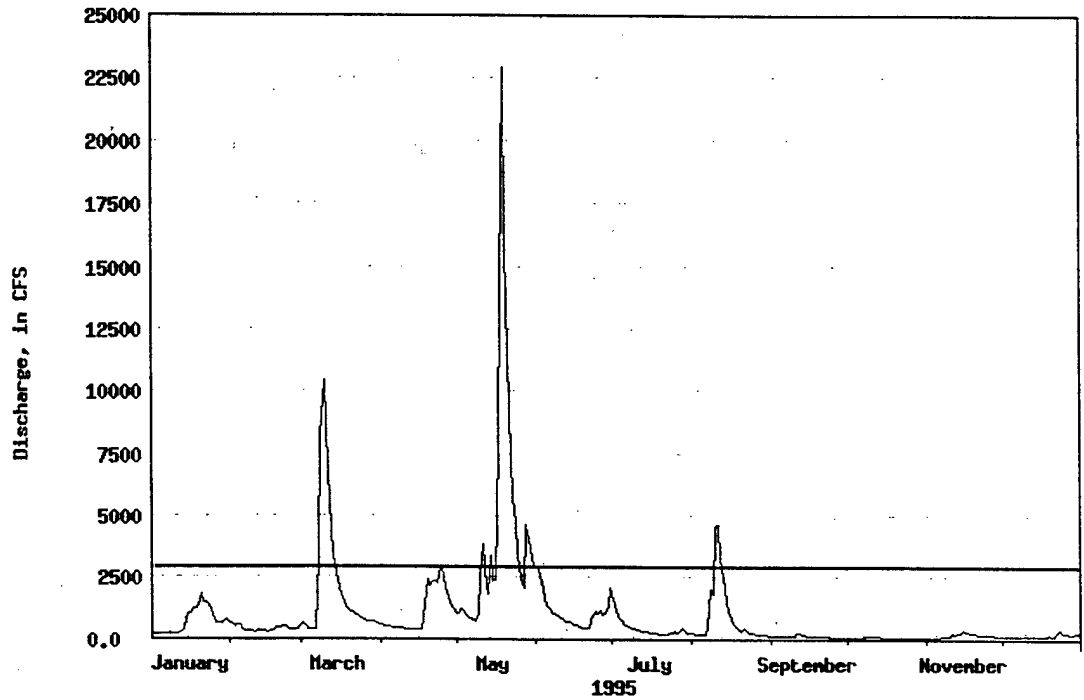
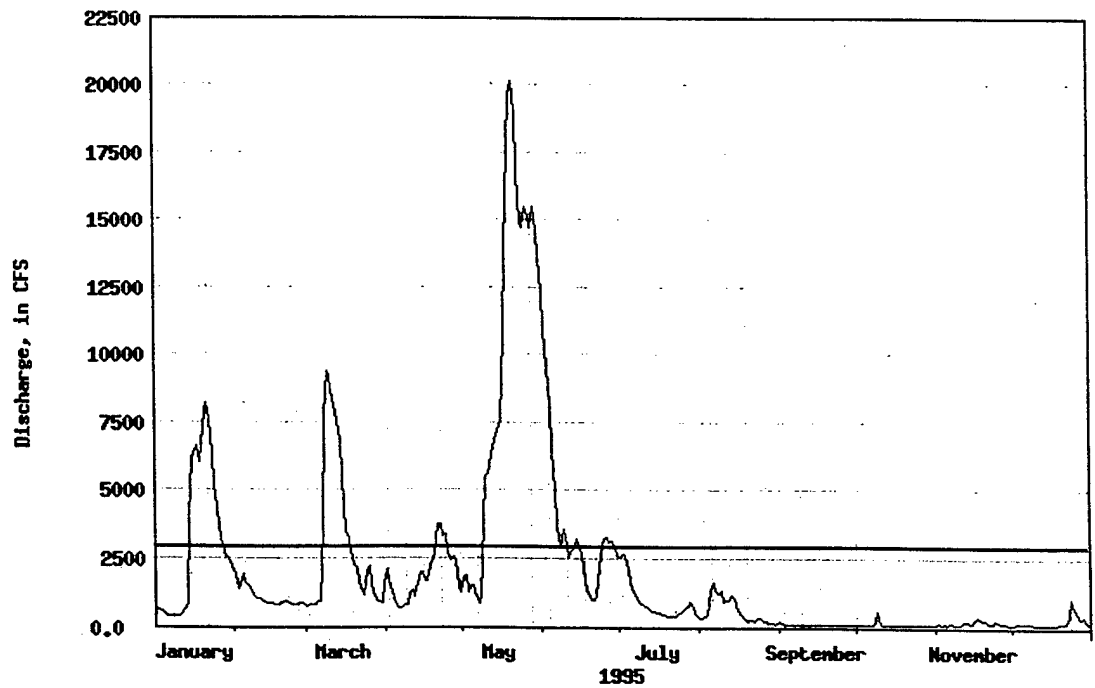
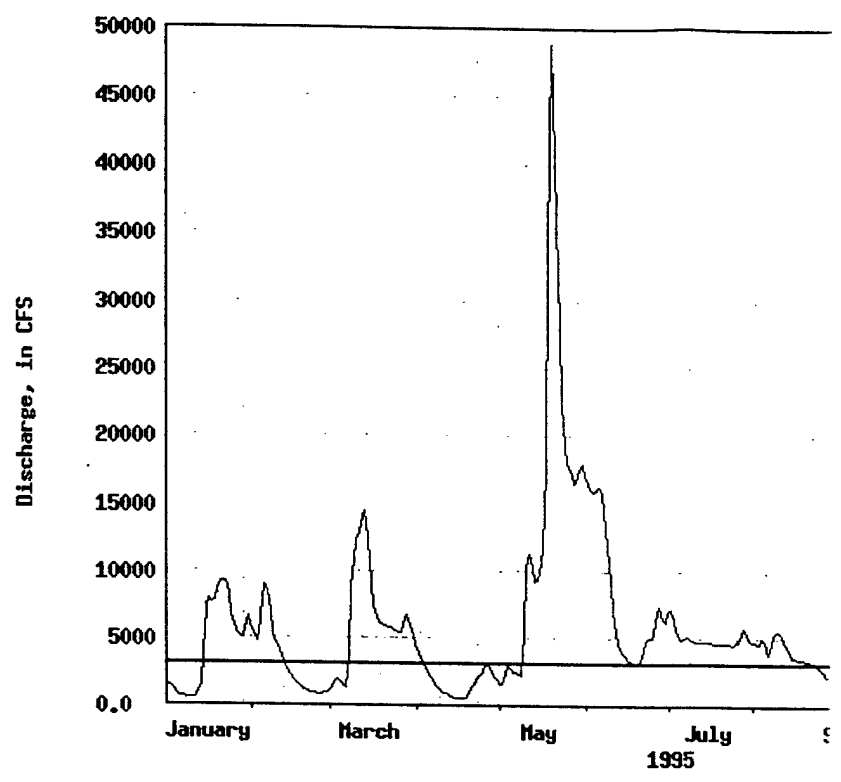
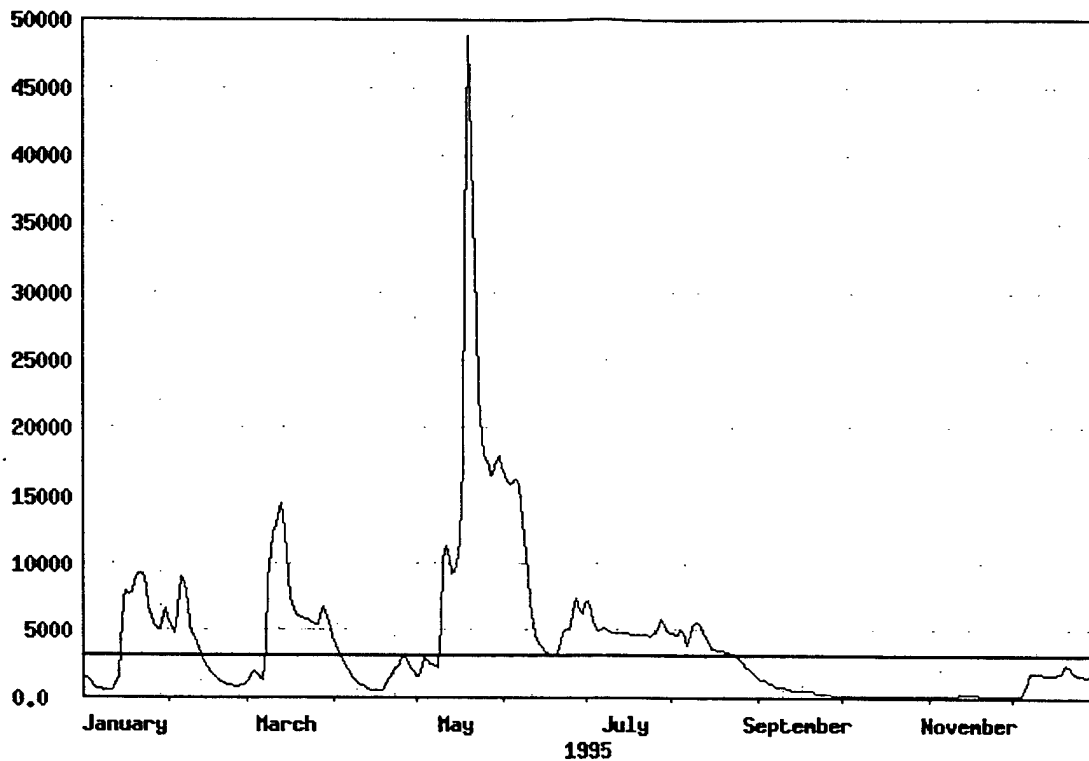
<p align="center"><b>U.S. ARMY ENGINEER DISTRICT, ST. LOUIS CORPS OF ENGINEERS ST. LOUIS, MISSOURI</b></p>	
<p>PREPARED BY: J. Boockern CHECKED BY: R. Delvey</p>	<p align="center"><b>KASKASKIA RIVER BANK EROSION STUDY</b></p> <p align="center"><u>1995 FLOW DURATIONS</u></p>	
		<p>PLATE NO. 11</p>

Another analysis was conducted examining the relative project effects of flow on vegetation along the banks of the Lower Kaskaskia. Analysis of flow durations before and after construction of the reservoirs indicated that longer durations of flow at or above the 3000-cfs level have occurred since initiation of the projects. This was based upon comparisons of average flow durations made between data from the Venedy Station gage and two unregulated rivers, the Embarras (Ste. Marie, Illinois gage) and Sangamon (Riverton, Illinois gage) Rivers (Plate 11). These rivers were picked because of their relatively close proximity to the Kaskaskia. "Bankful discharge" at the three gage sites, assumed to be the discharge for the 1.5 year recurrence interval, was approximately 17,000 cfs, 10,500 cfs, and 14,000 cfs respectfully. "Bankfull stage was approximately 20 ft., 18 ft., and 17 ft.

**Duration above 3,000 cfs disch**  
 Embarras River = 69 da  
 Sangamon River = 76 da  
 Kaskaskia River = 175 d
